**UNITED STATES ENVIRONMENTAL PROTECTION AGENCY
REGION 10
1200 6TH AVENUE
SEATTLE, WASHINGTON 98101**

SUBJECT: CLEAN AIR ACT INSPECTION REPORT
Republic Services Coffin Butte Landfill, Corvallis, OR

Facility Name: Republic Services Coffin Butte Landfill

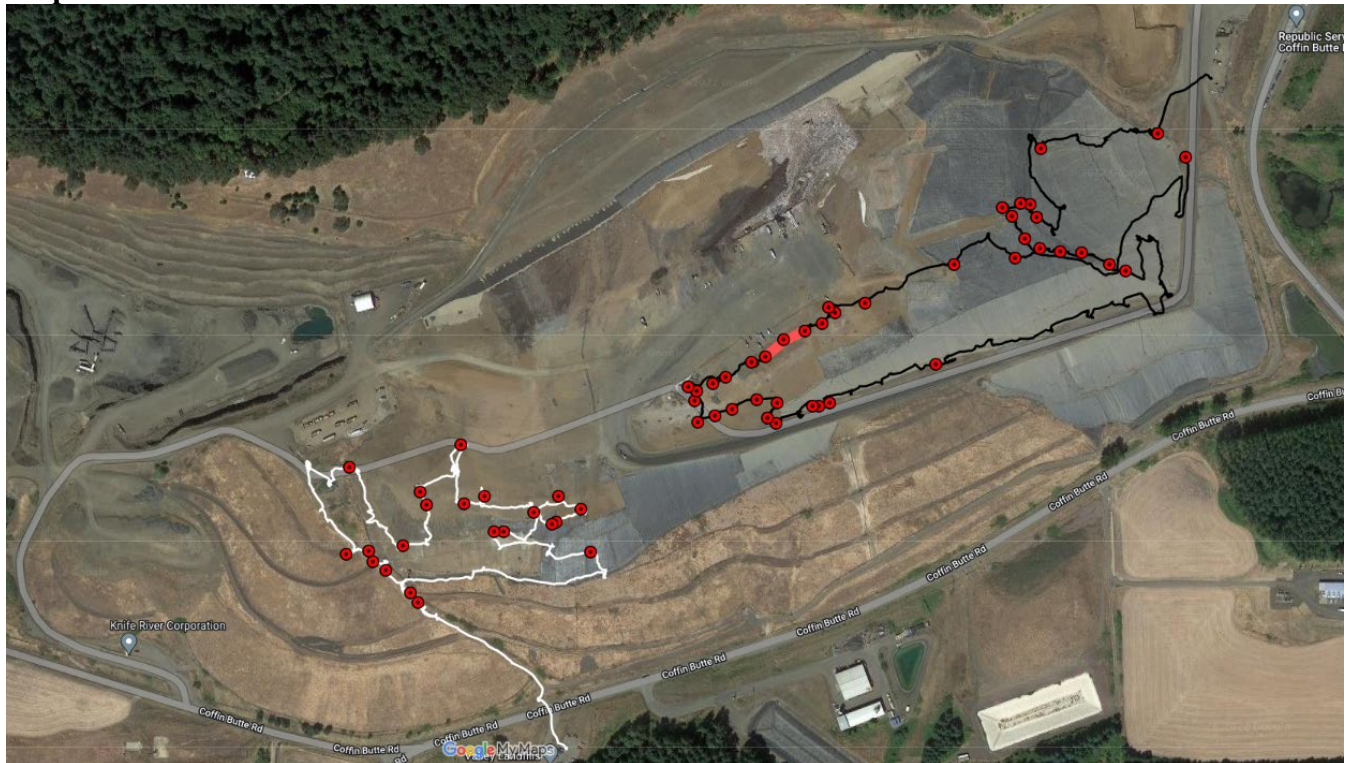
Map of Detected Exceedances

SEM exceedance locations plotted over Google Maps satellite imagery. Approximate monitoring paths included, derived from GPS data. Morning path shown in white, afternoon in black. Line of continuous exceedance at every tarp hole between flags 52 and 54 is highlighted in red.
